# Building Condition Assessment Report

<b>Asset</b>	C3b - Holly Drive Cottage 107	
<b>Address</b>	Riverview Lands, 2601 Lougheed Highway, Coquitlam, BC. V5C 4J2	
<b>Construction Year</b>	1920.	
<b>Size (Gross Floor Area)</b>	3,600	Sq.Ft.
<b>Asset Type</b>	RV_Cottage 107 etc., 2 Story Vinyl Siding & 15% Brick Veneer / Wood Frame	
<b>Floors Above Ground.</b>	2	
<b>Report Date</b>	October 2013

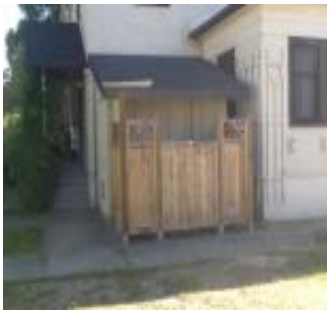
<u>Replacement Value</u>	\$6,000		
<u>What &amp; Where</u>	Exterior mechanical/fuel storage room. 3 - 150 lb. propane fuel storage tanks, interconnected.		
<u>Commentary (Condition ...)</u>	Propane fuel storage forms part of new hot water heat source installation. Tanks monitored and filled by service provider.		
<b><u>Action</u></b>	<b>1.</b>		
<u>Action Type</u>	Maintenance		
<u>Action Cost</u>	\$1,000		
<u>Action Year</u>	2014.		
<u>Brief Description</u>	Annual preventative/predictive maintenance.		
<u>Commentary</u>	Service should be maintained for optimal performance.
