# Building Condition Assessment Report

<b>Asset</b>	C3b - Holly Drive Cottage 109	
<b>Address</b>	Riverview Lands, 2601 Lougheed Highway, Coquitlam, BC. V5C 4J2	
<b>Construction Year</b>	1915.	
<b>Size (Gross Floor Area)</b>	3,714	Sq.Ft.
<b>Asset Type</b>	RV_Cottage 107 etc., 2 Story Vinyl Siding & 15% Brick Veneer / Wood Frame	
<b>Floors Above Ground</b>	2	
<b>Report Date</b>	October 2013

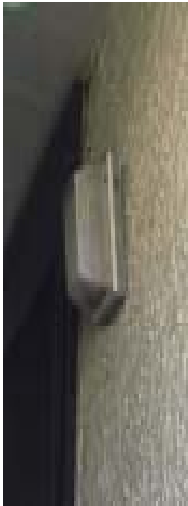
<u>Replacement Value</u>	\$3,500		
<u>What &amp; Where</u>	Fixtures typically original to construction of building. Mix of metal halide, fluorescent and incandescent.		
<u>Commentary (Condition ...)</u>	Lighting - General With advances in technology, there are opportunities for energy savings that will offset the cost of lighting retrofits. For example, the cost of LED lighting, which uses far less energy than traditional fluorescent or incandescent lights has reduced drastically, and may be an economical choice. Also, T-5 fluorescent fixtures use less energy than T-8 fixtures.

<b><u>Action</u></b>	<b>1.</b>
<u>Action Type</u>	Study
<u>Action Cost</u>	\$0
<u>Action Year</u>	2014.
<u>Brief Description</u>	Undertake a lighting study or energy audit to investigate/determine energy savings.
 <u>Commentary</u>	 Consider a Consultant Study to define scope of work and order of magnitude for multiple buildings on site to achieve economies of scale. See "Branch wiring".
